Attention RM of Hillsdale Council

The RM of Hillsdale Council requested Wood PLC to investigate concerns council has with safety issues regarding the Baldwinton access road off Highway #40. The portion of the road that is in question is a paved asphalt surface that is approximately 750 meters in length and is located E.pt. NE 21-44-23-W3 and E.SE 21-44-23-W3.

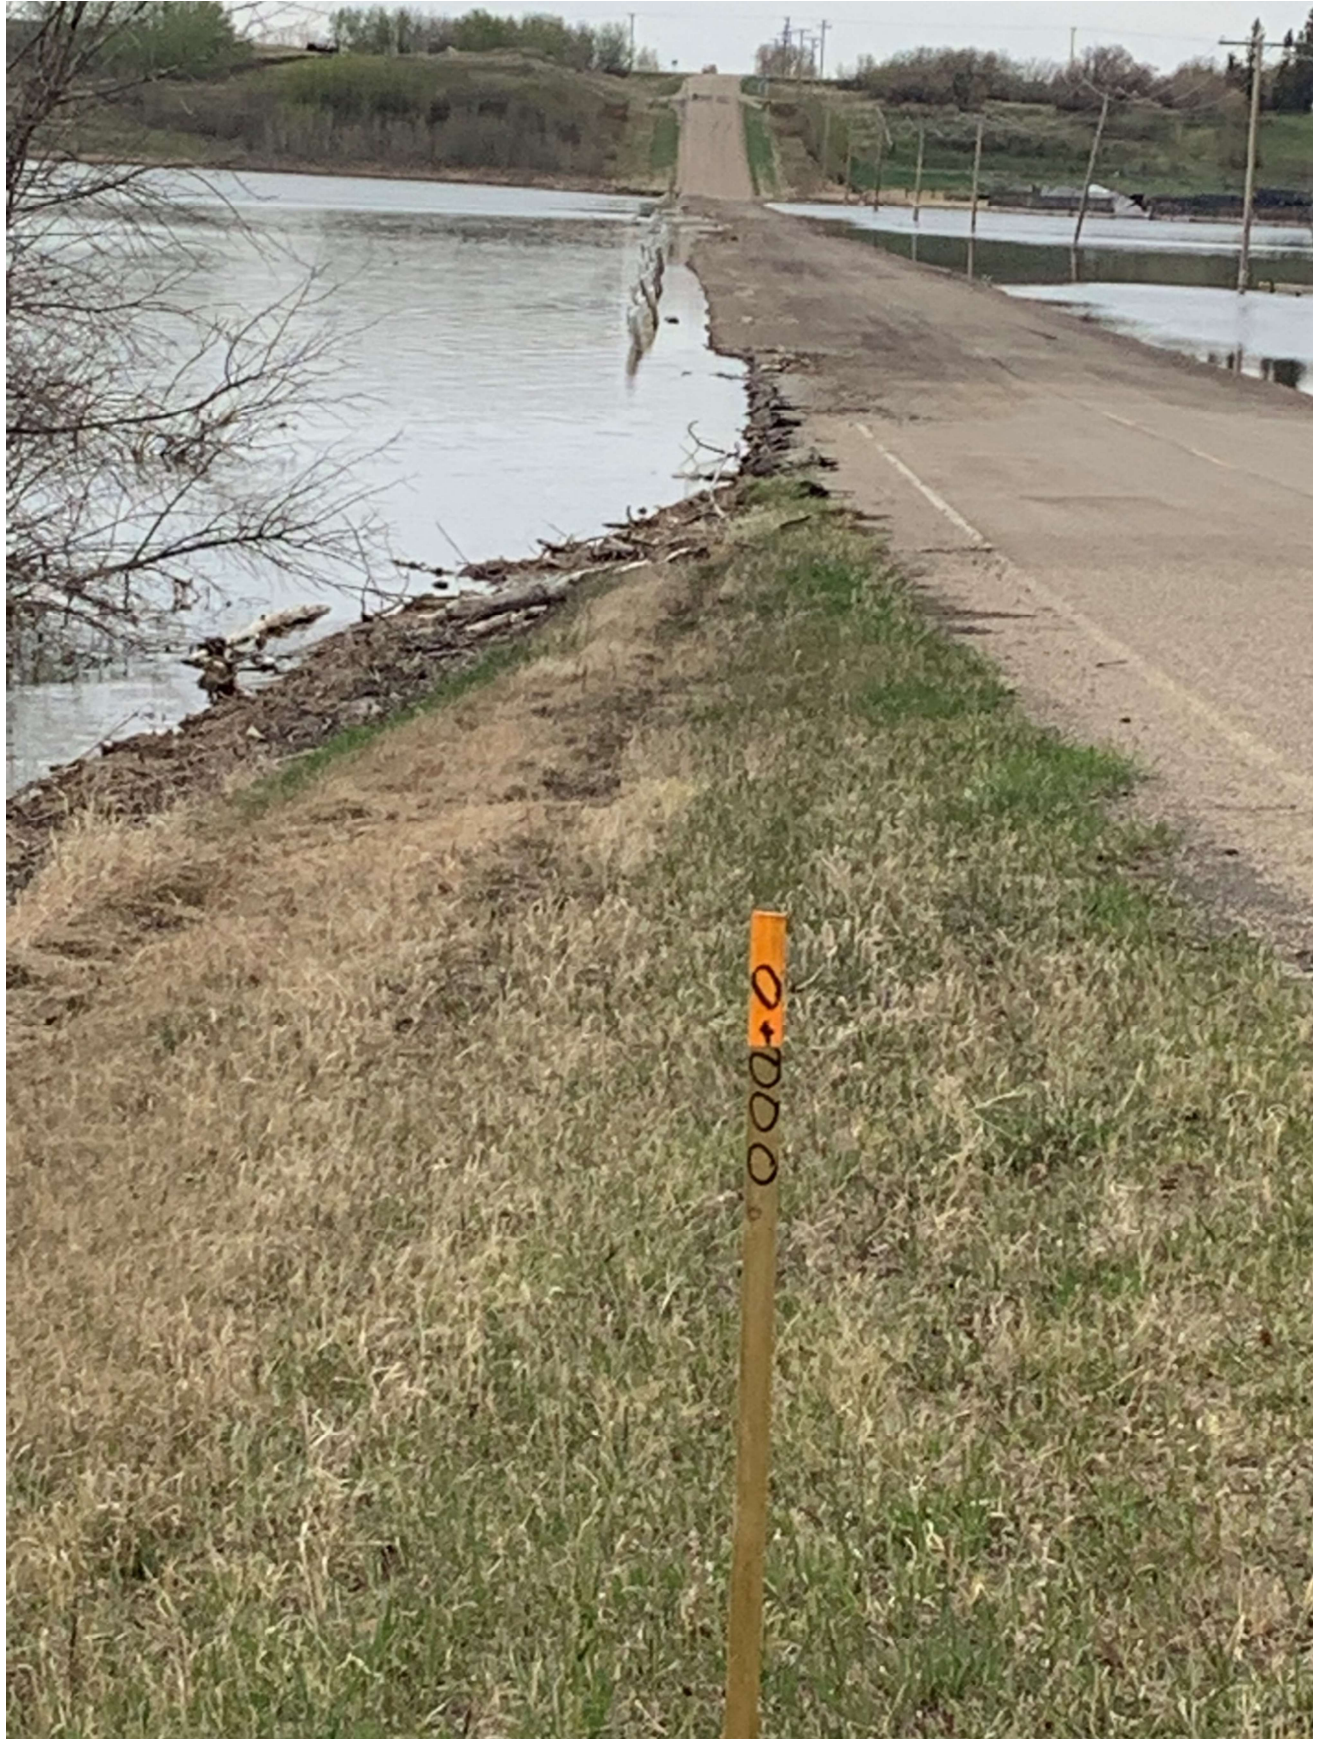
Photo 1

The municipality installed concrete barricades to the west side slope to help deter erosion from wave action. Refer to photo (#4). Both sides of the existing road top and side slopes have erosion issues. The west edge of the road and side slope show extreme erosion problems with the east road edge and side slope showing erosion to a lesser extent. The asphalt structure on the edge of the road top surface is deteriorating and crumbling. Refer to attached photos (#1 and #10).

Due to the conditions noted above and the potential for user safety, liability to the R.M. and potential further damages to the road it is the opinion of Wood PLC that the portion of the Baldwinton access road located E.pt. NE 21-44-23-W3 and E.SE 21-44-23-W3 should remain closed at this time.

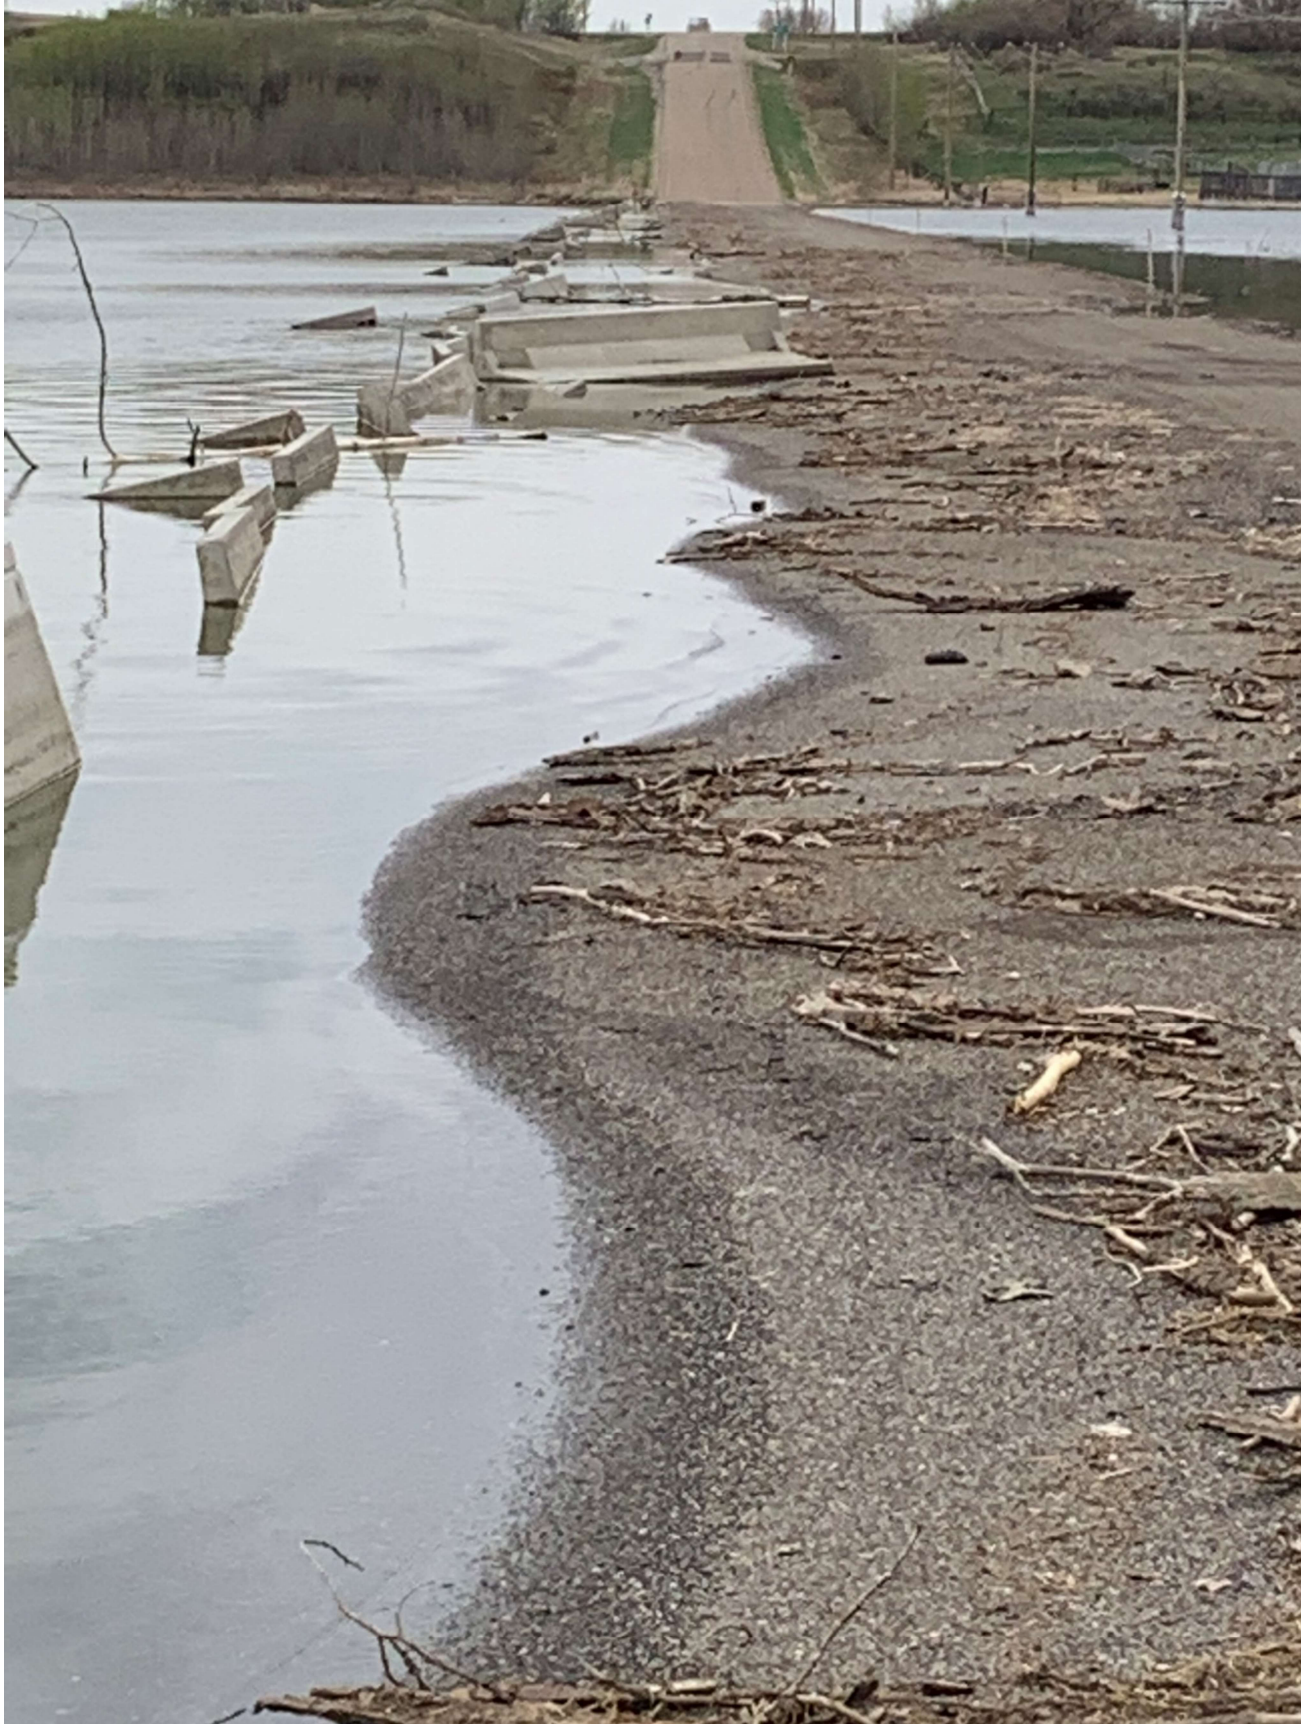
Photo 4

The initial assessment of the road shows that water had previously breached the existing road top and has since receded to a point where the road top is visible again with traces of debris scattered on the road top. Refer to attached photos (#4 and #7).

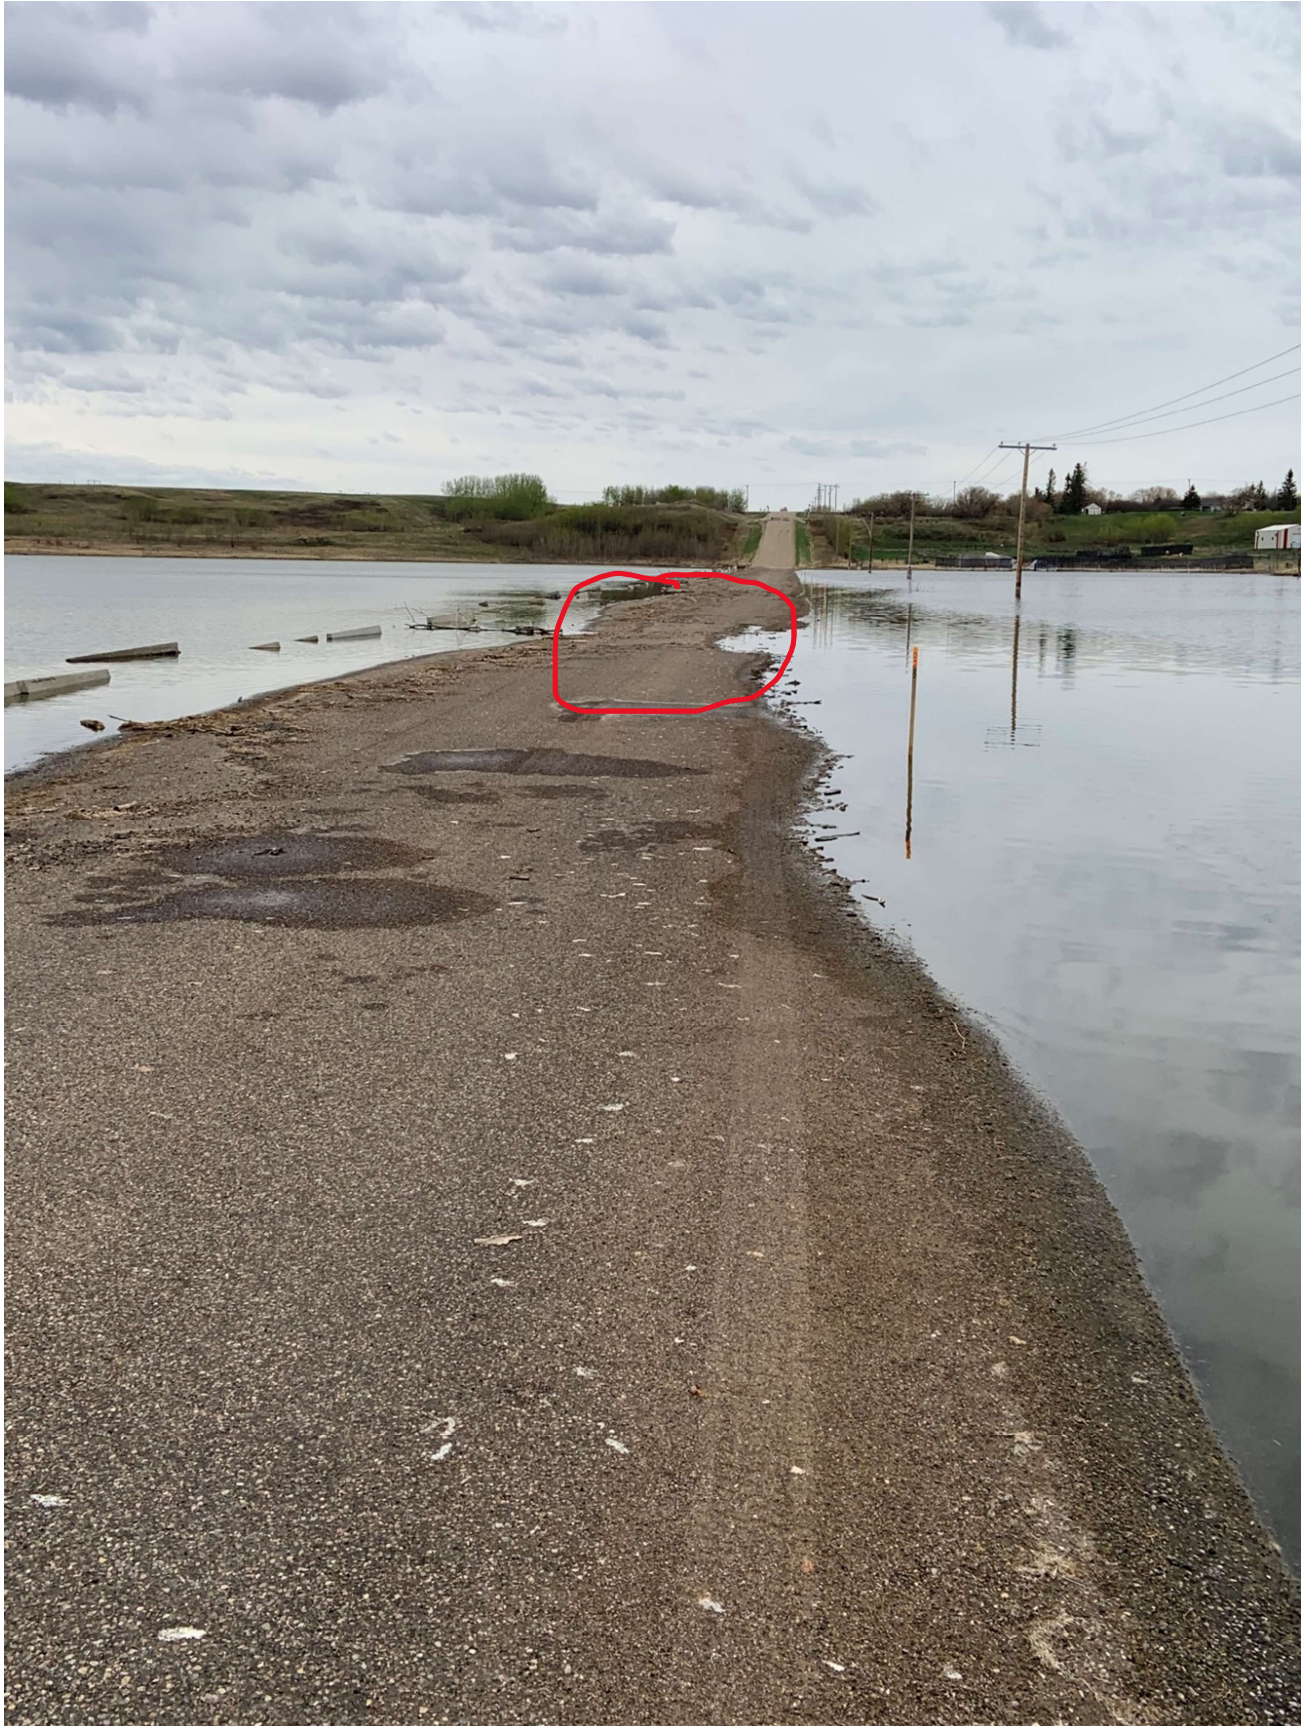
Photo 5

There is evidence that moisture is migrating to the surface of the road top through small hairline cracks in the asphalt surface as determined in photo (#6). There are five locations along this section of road that is noticeably settling or sinking as well. Refer to attached photos (#5, #7, #8 and #9).

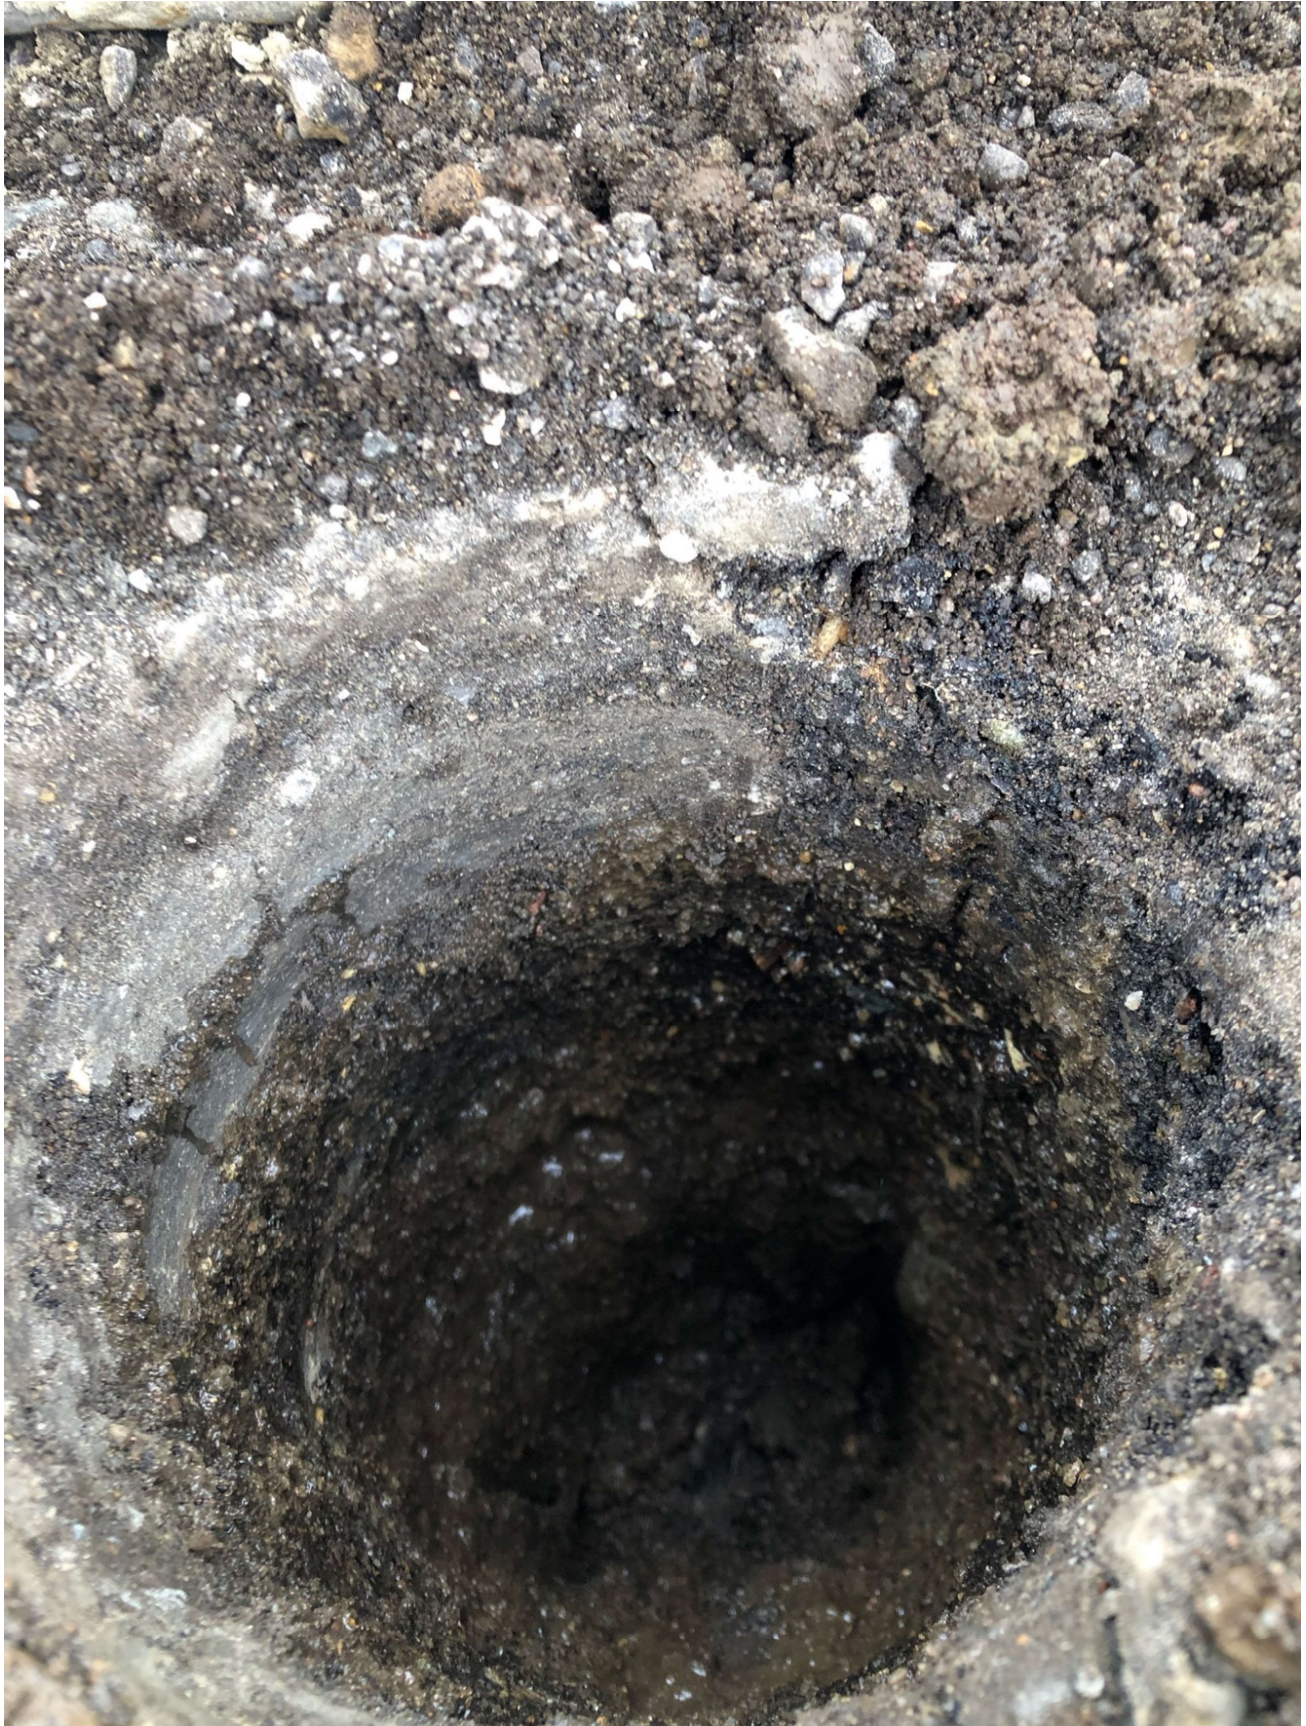
Photo 11

Station #0+100 (photos #11, #13 & #15)

- 4" asphalt
- 6" wet base gravel
- 10" wet clay material
- 24" wet, saturated dark mushy material

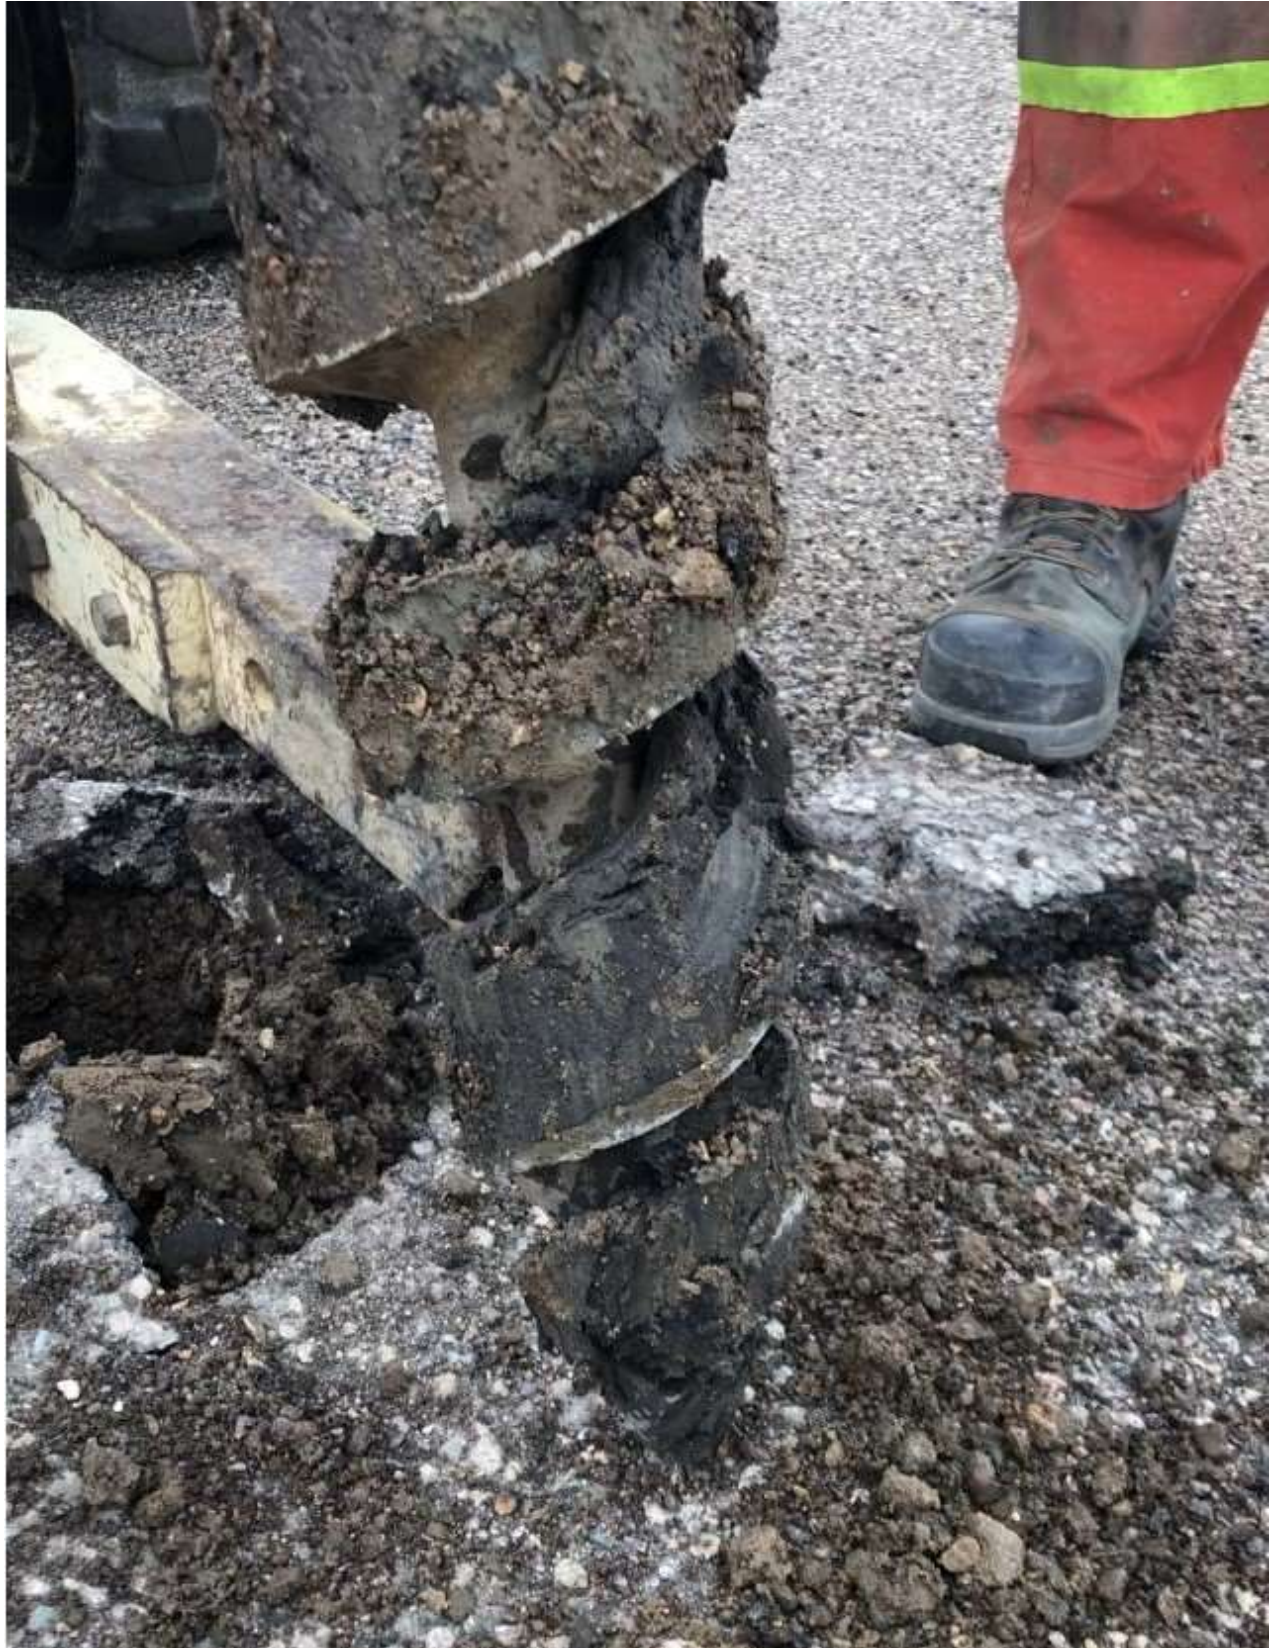
Photo 14

Station #0+200 (photo #14 & 16)

- 4" asphalt (2" asphalt separating)
- 6" wet base gravel
- 10" wet clay material
- 10 "wet, saturated black material

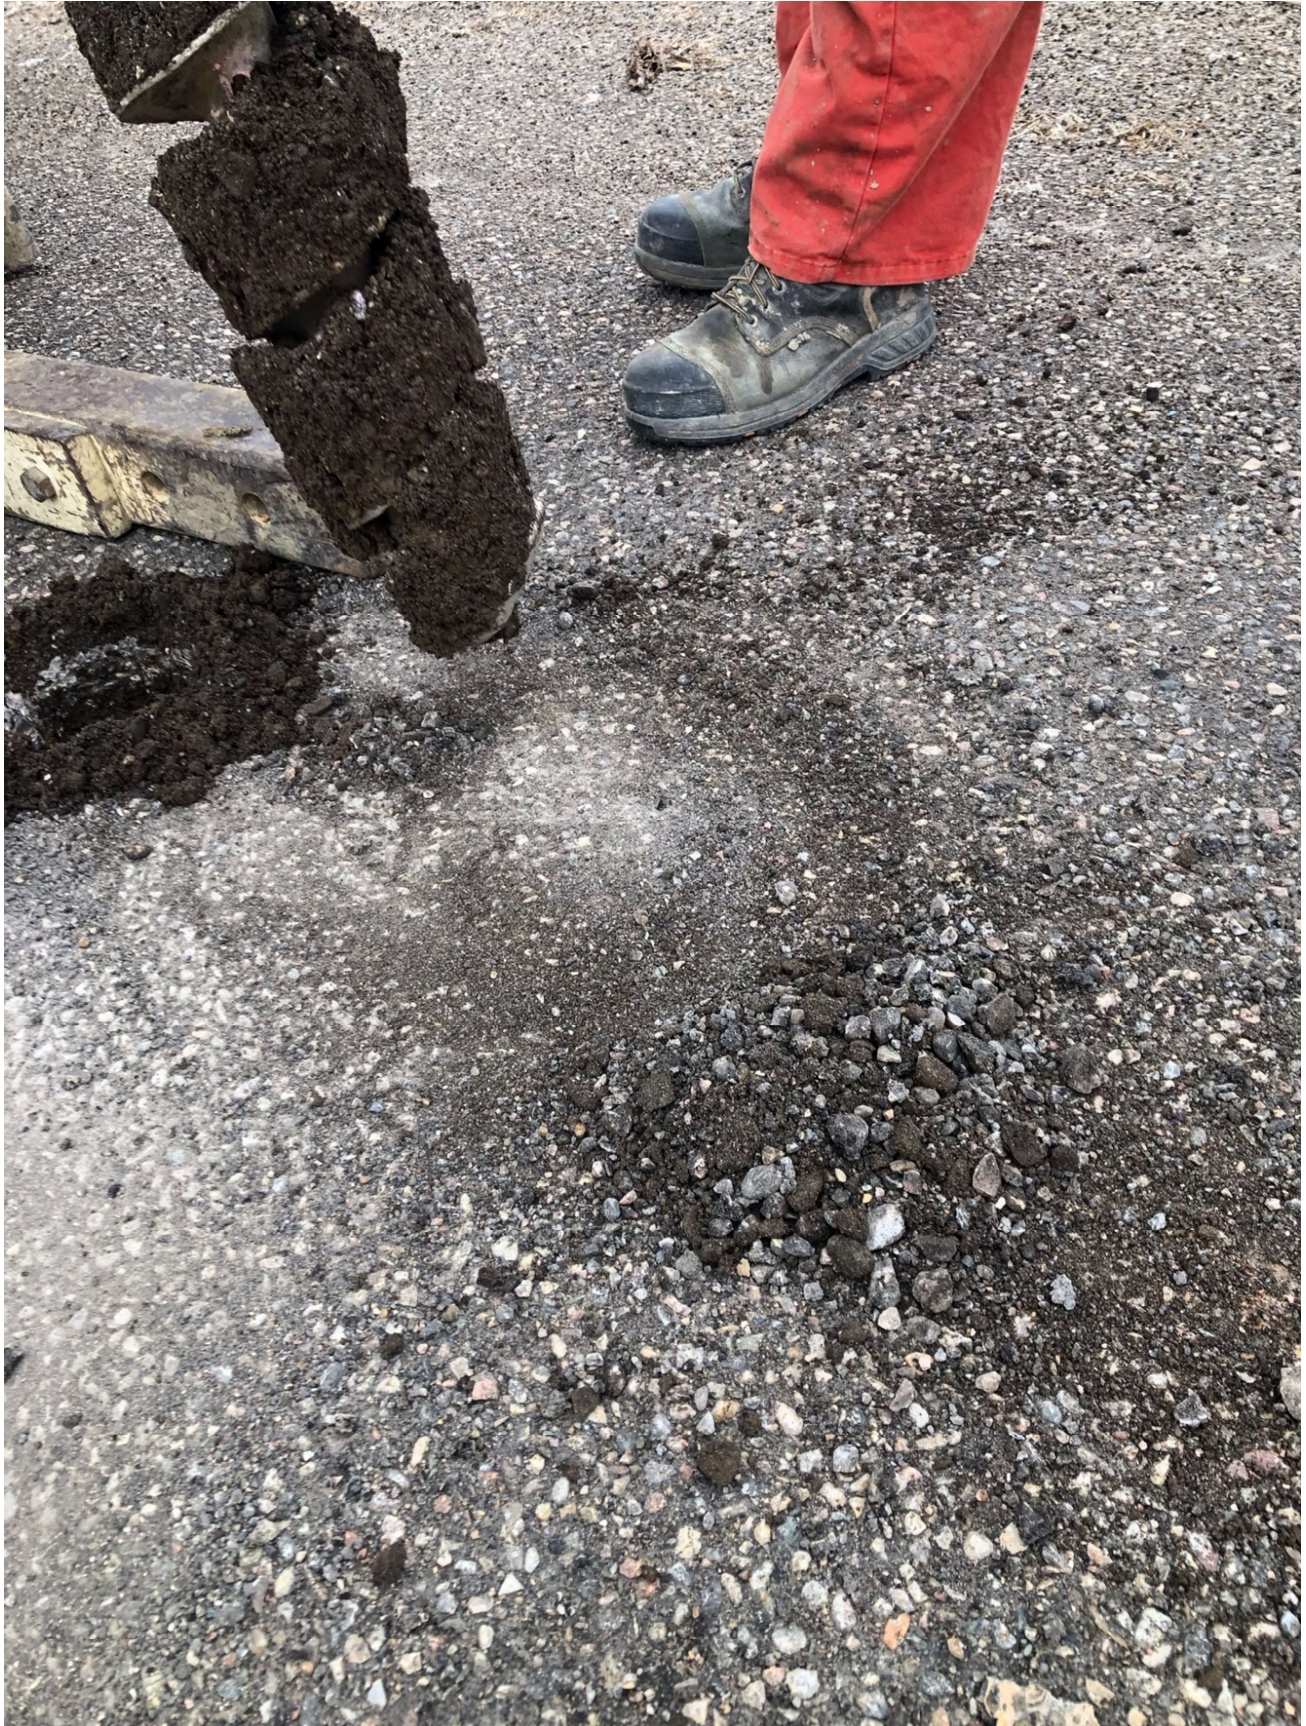
Photo 15

All bore holes determined approximately four inches of asphalt structure with six inches of wet base gravel, with one location where water was seeping into the bore hole through the base gravel and directly below the asphalt. The clay material directly below the base gravel (approximately ten inches thick) is very wet. The material below the clay material (20-24 inches thick) is very wet, saturated dark black material as seen in photo (#15).

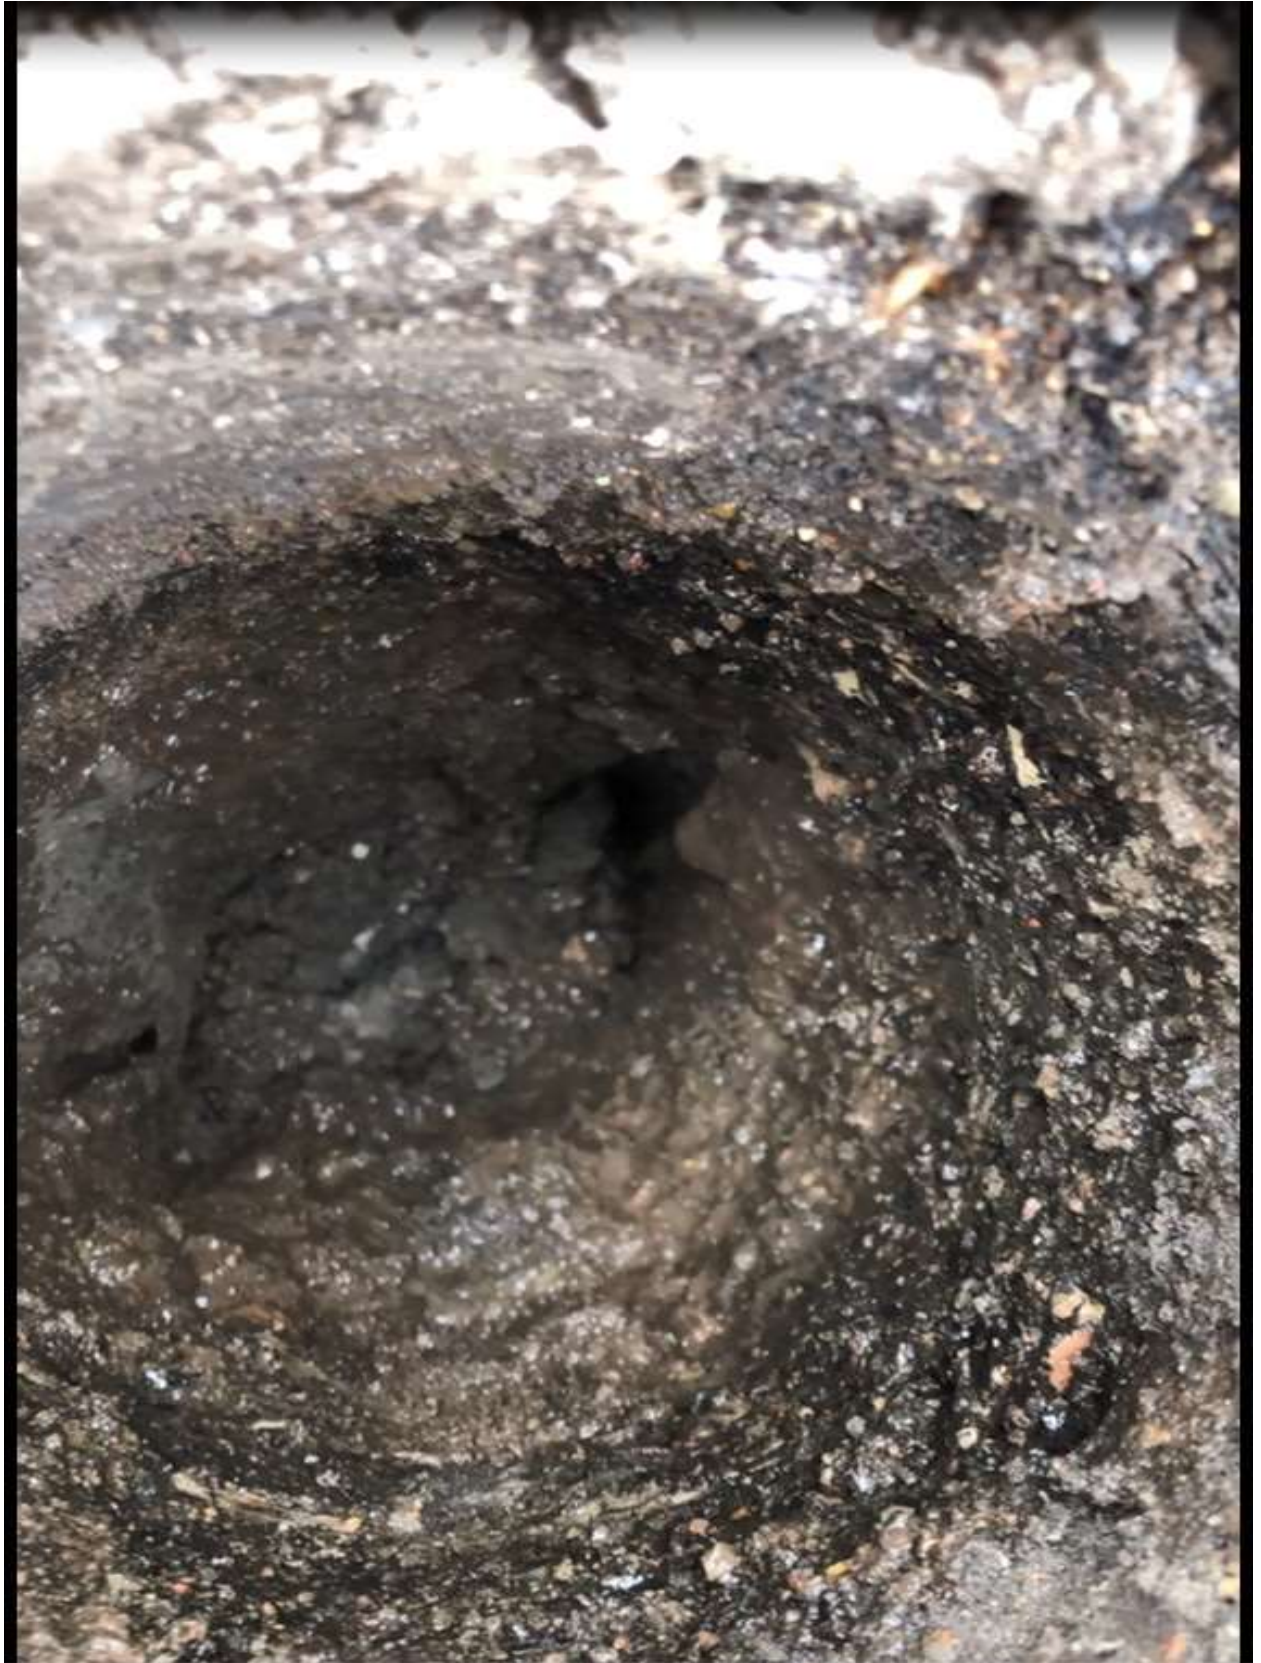
Photo 17

Station #0+300 (photo #17)

- 4" asphalt
- 6" wet base gravel → water seeping into bore hole
- 12" wet clay material
