Attention RM of Hillsdale Council

The RM of Hillsdale Council requested Wood PLC to investigate concerns council has with safety issues regarding the Baldwinton access road off Highway #40. The portion of the road that is in question is a paved asphalt surface that is approximately 750 meters in length and is located E.pt. NE 21-44-23-W3 and E.SE 21-44-23-W3.

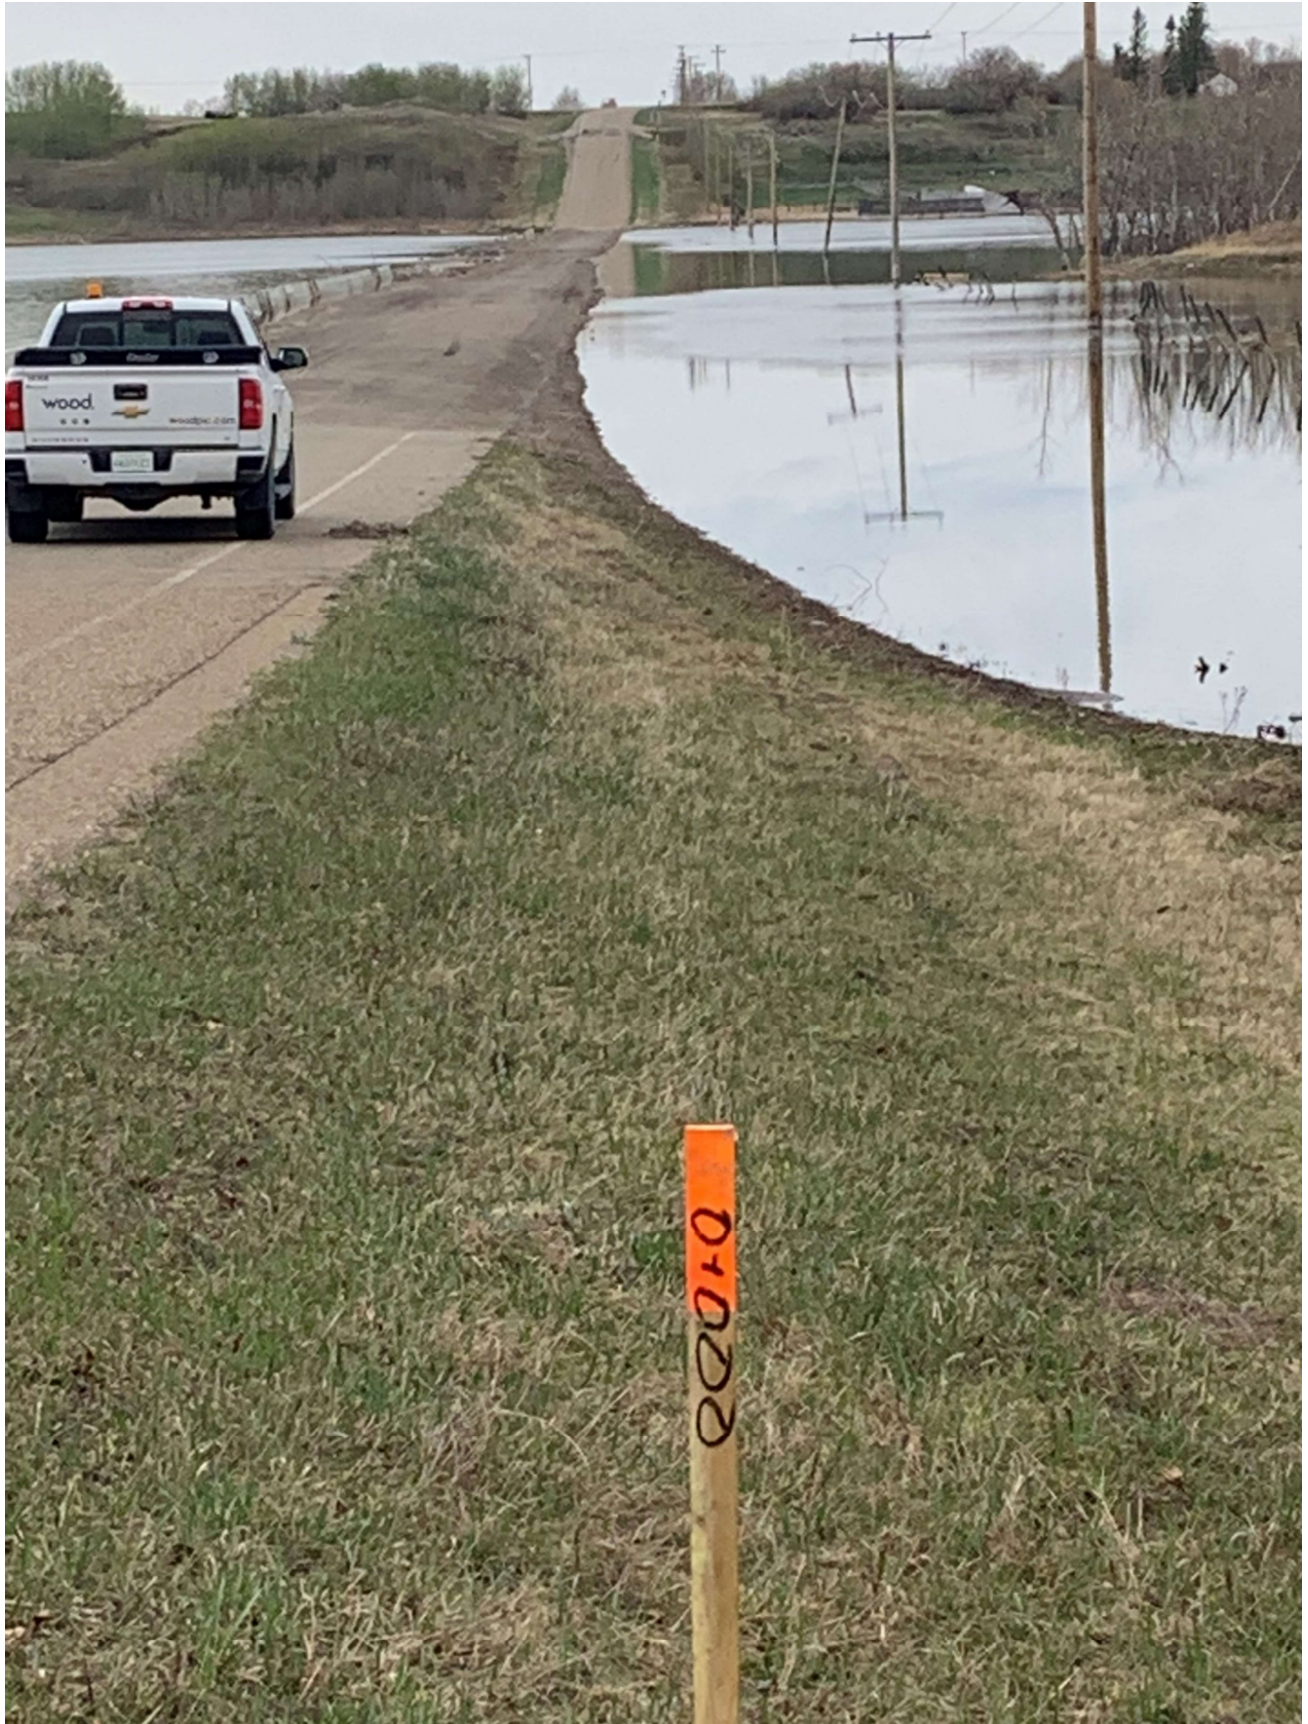
Photo 1

The municipality installed concrete barricades to the west side slope to help deter erosion from wave action. Refer to photo (#4). Both sides of the existing road top and side slopes have erosion issues. The west edge of the road and side slope show extreme erosion problems with the east road edge and side slope showing erosion to a lesser extent. The asphalt structure on the edge of the road top surface is deteriorating and crumbling. Refer to attached photos (#1 and #10).
